## HISTORIC TIMBER REPAIR TECHNIQUES TYPOLOGY IN HERITAGE BUILDING CONSERVATION; AN ANALYSIS OF MALAYSIAN PRACTICE

**Keywords:** Historic Timber, Replacement Timber, Repair Works, Building Conservation

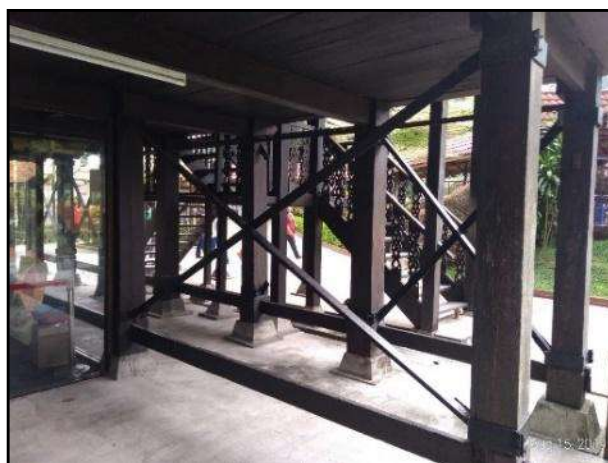
**Figure 3:** The additional structure consolidation by steel braces on the columns of Istana Satu was once relocated to the Malaysia National Museum compound (Author, 2019).

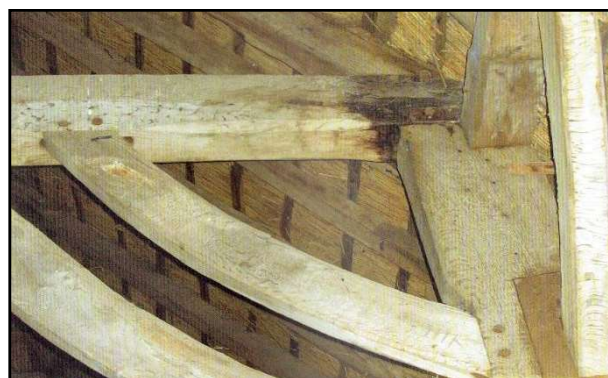
**Figure 6:** The Epoxy resin repair to the end of a beam consolidated and replaced the missing part (English Heritage, 2012).

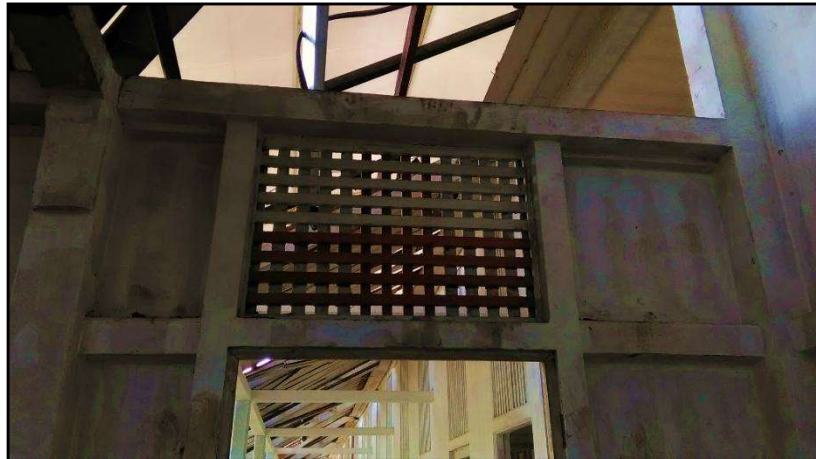
**Figure 8:** Some of the replaced timber lattice members, which remain unfinished, were replicated based on the original ones that are still intact (Author, 2017).

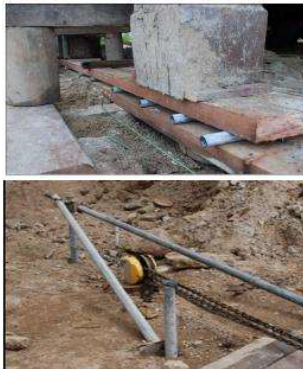
Slicing new timber into the joint of the original structure strengthens the connection while replacing the decayed portion.
v	Relocate /Reinstall	Decisions are made when a building needs to be removed or repositioned. Some repairs are necessary.	Dragging a house within a short distance.

The building is moved to a new location using a prepared pipe track (top) and pulled with a chain hoist (below). This technique is only used for relocating buildings over very short distances.
